NOAA Technical Memorandum NMFS-AFSC-152

Using Digital Video Monitoring Systems in Fisheries: Application for Monitoring Compliance of Seabird Avoidance Devices and Seabird Mortality in Pacific Halibut Longline Fisheries

R. T. Ames, G. H. Williams, and S. M. Fitzgerald

April 2005

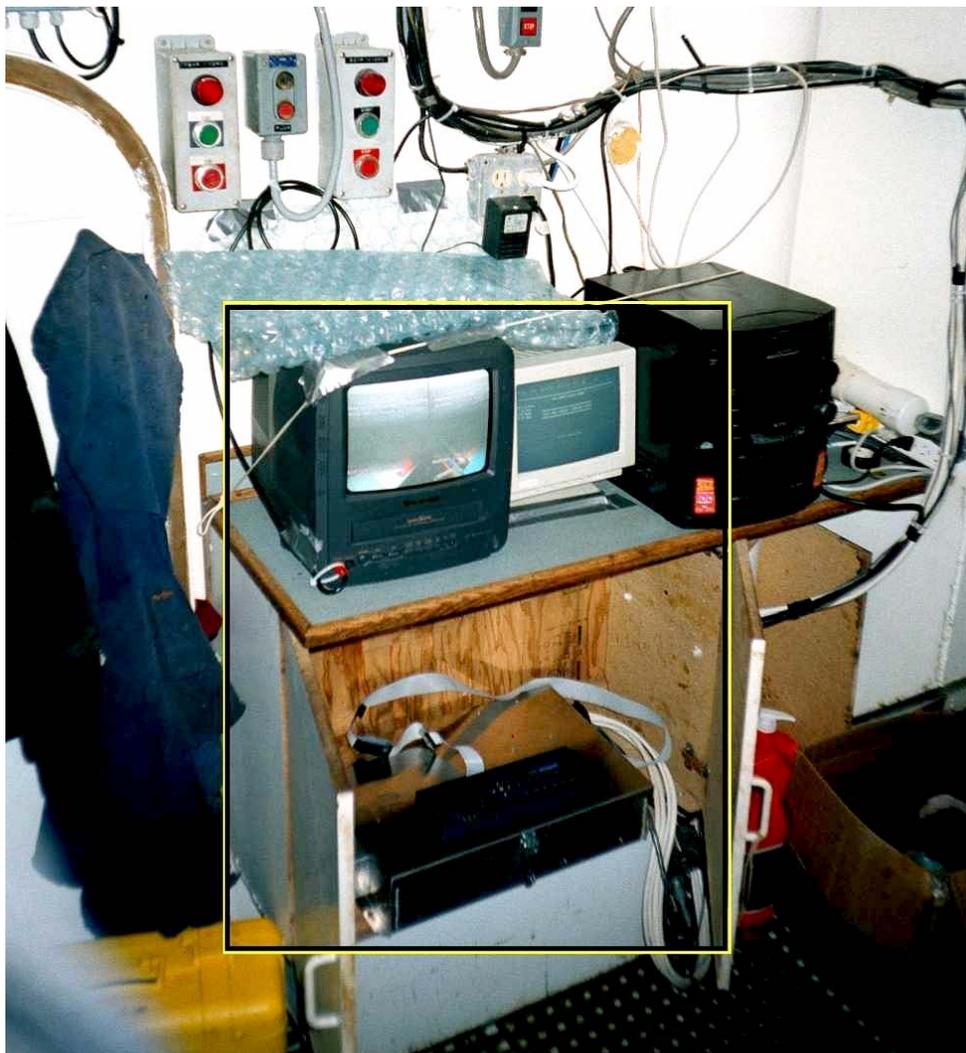
Figure 2. Electronic Monitoring System set-up used on the F/V *Pacific Sun*, featuring the computer control box, status display monitor, and TV monitor.

vessel's standing structure with a universal stainless steel mount using band straps. The camera electronics inside the sealed case are attached to a rotary gimbal mount that allows for a quick directional adjustment of the fixed lens camera. Selecting from a set of lenses ranging from fisheye to telephoto, the sea-sampler can adjust the field of view and the image resolution optimally for each application. A TV monitor was included in the EMS to allow real-time viewing of each camera image and permit video playbacks of set and haul imagery (Fig. 2).

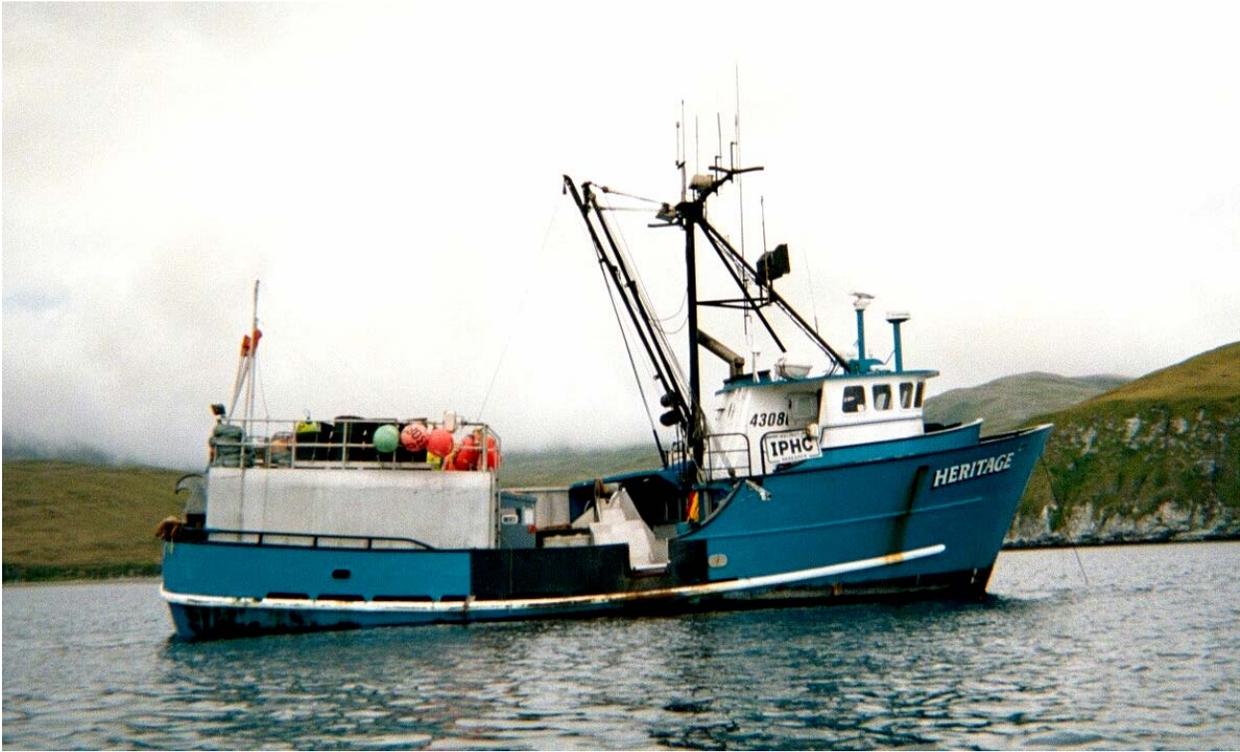
Figure 4. The F/V *Heritage*, a 20-m length overall vessel chartered by the International Pacific Halibut Commission.

- The 3-month survey provided multiple fishing trips and allowed for an extended deployment of the EMS units.
- The two vessels were of different size, shape, and deck layout, which allowed for additional information on the adaptability of the EMS units. The vessels were typical of the larger vessels involved in the halibut fishery. Images of the vessels are provided in Figures 4 and 5.

- Figure 3.** IPHC regulatory areas and 2002 assessment survey stations.
- Figure 4.** The *F/V Heritage*, a 20-m LOA vessel which fishes Pacific halibut, chartered by the International Pacific Halibut Commission to conduct a stock assessment survey.

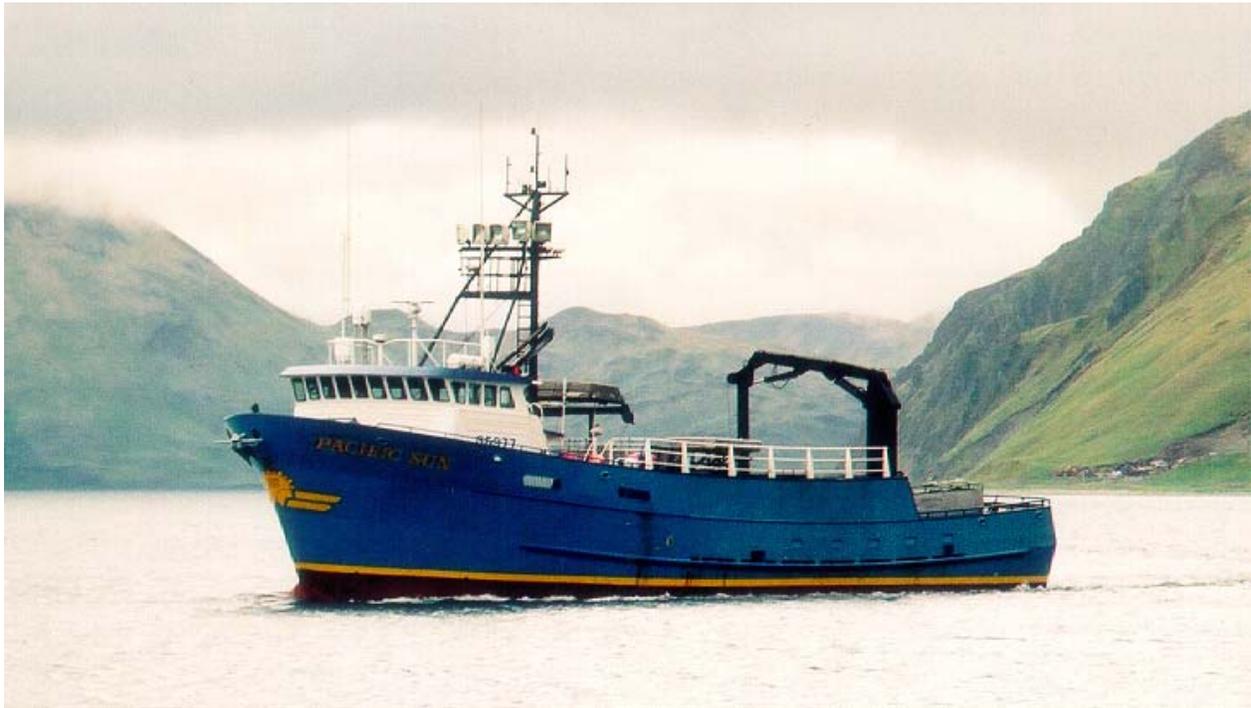
Figure 5. The F/V *Pacific Sun*, a 37-m steel hull vessel chartered by the International Pacific Halibut Commission. Photo courtesy Sara Wilson, IPHC.

- Figure 5.** The *F/V Pacific Sun*, a 37-m steel hull vessel which fishes for Pacific halibut, chartered by the International Pacific Halibut Commission to conduct a stock assessment survey.
